Manhole Inspection Summary

Manhole # S29KK_029MH

Location Address: **601 LENNOX ST**

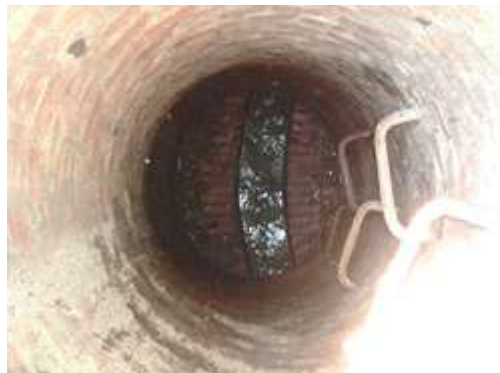
Top View

Corroded and missing steps. Bench debris.

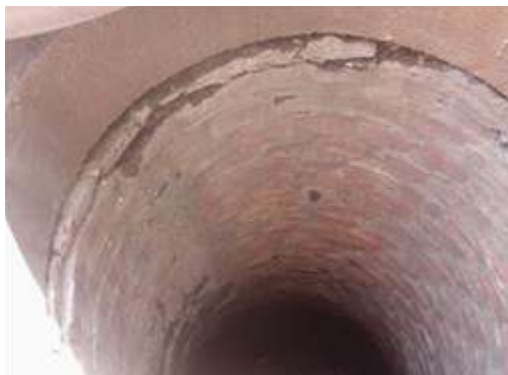
Defect

Frame leaks. Adjustment deterioration and infiltration. Barrel infiltration - other side.

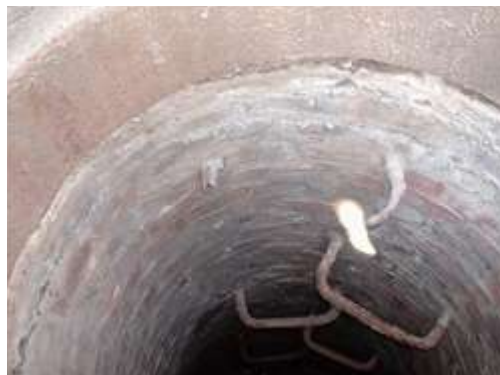
Defect

Frame leaks. Adjustment deterioration and infiltration. Barrel infiltration.

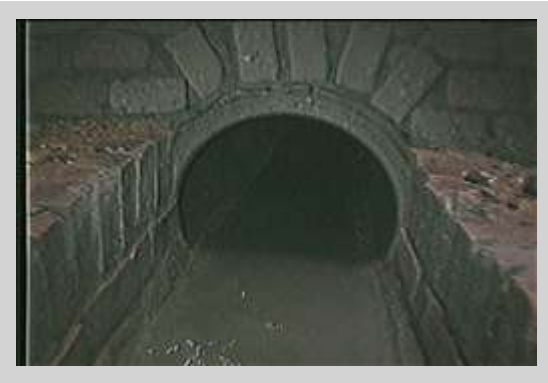
12 in. Circular Gravity Sewer Pipe Out @ 12 O'Clock

Channel deterioration.

Deposits: ☐ None ☐ Mud ☐ Sludge ☐ Debris ☒ Grease

Infiltration: **None** Pipe Seal Cond: **Cracked**

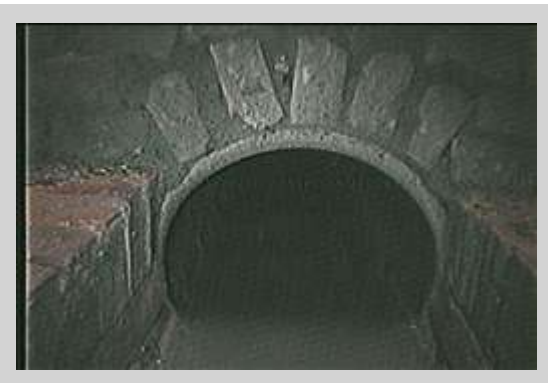
12 in. Circular Gravity Sewer Pipe In @ 5 O'Clock

Infiltration: **None** Pipe Seal Cond: **Unknown**
